Axiom Property Inspections Property Inspection Report

868 Wally Avenue, Henderson NV, 89178 Inspection prepared for: John Doe Agent: David Lawson - Axiom

Inspection Date: 8/12/2010 Time: 2:30 PM Age: Built in 2006 Size: 2372 sq ft Weather: Clear and 94 degrees

Inspector: David Lawson Nevada License #IOS0001580RES

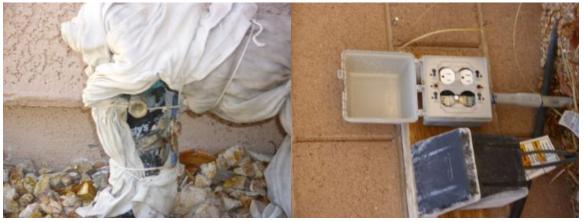
7. Grounds Electrical
Observations: • Improperly installed switch at water feature. A switch can not be installed in a receptacle cover. In need of correct cover plate.

10. Plumbing
Good Fair Poor N/A None Materials: Copper piping noted. • PVC piping noted.
X Observations: • Gate valve to sprinkler system is corroded and in need of replacement. • Water feature in back yard is not functional. Pump is disconnected and was not inspected.

GAte valve corroded from leak

Switch incorrectly installed

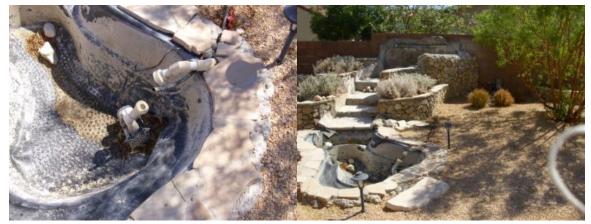
Disconnected water feature pump

Inoperable water feature

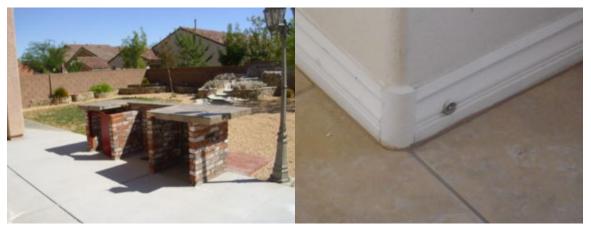
Grilling area with no equipment installed Door stop broken at entry double doors

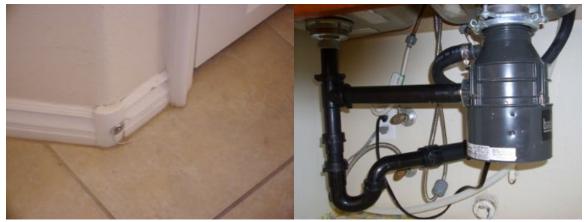
• Garbage disposal is jammed and will not operate. Recommend repair by licensed professional.
6. Microwave
Good Fair Poor N/A None
7. Cook top condition
X Gas cook top noted.

Broken door stop at door at bottom of stairs

Jammed garbage disposal

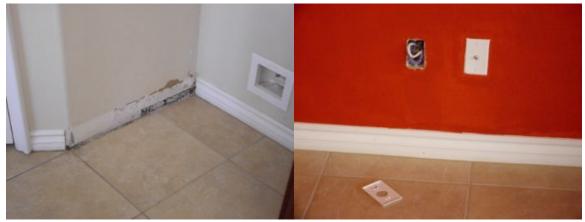
23. Electrical Good Fair Poor N/A None X	
24. GFCI	
Good Fair Poor N/A None	
X	
25. Wall Condition	
Good Fair Poor N/A None	Materials: Drywall walls noted.
X	Observations:
	• Missing a piece of baseboard in refrigerator area, In need of repair. We recommend the use of a certified professional.

Missing base trim at refrigerator area

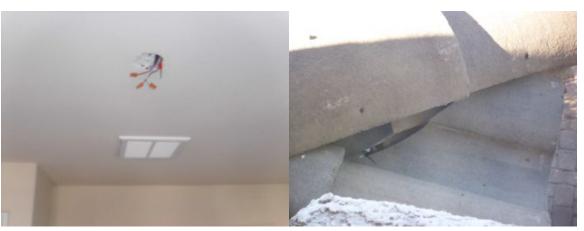
Missing cover

Improperly installed roof tile at hip in front

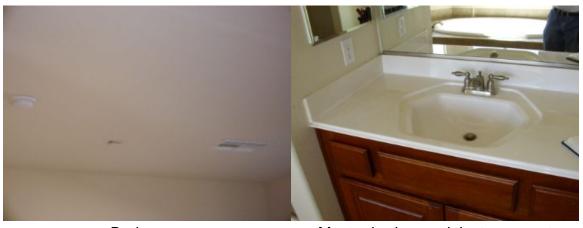
Master bedroom entry door has split in end of door Exposed electrical wiring needs cover Master bedroom

Master bedroom sink stopper not connected

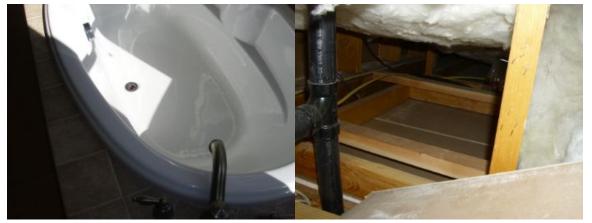
Master bath tub stopper missing

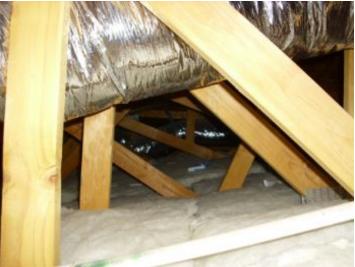
Typical attic insulation
